# Manhole Inspection Summary

Manhole # S41U\_\_018MH

Insp Date: **3/13/08 4:23 PM**

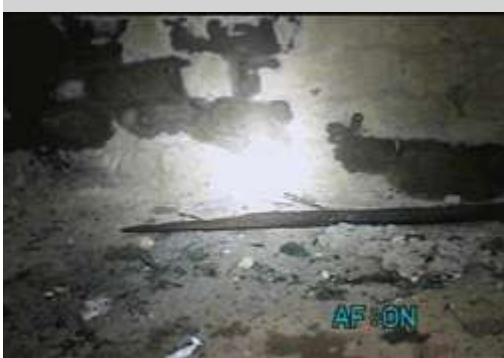
Defect 2

Infiltration: ☐ None ☐ Joint ☐ Cracks ☐ Mortar ☐ Roots ☒ **Wall**

Barrel wall infiltration

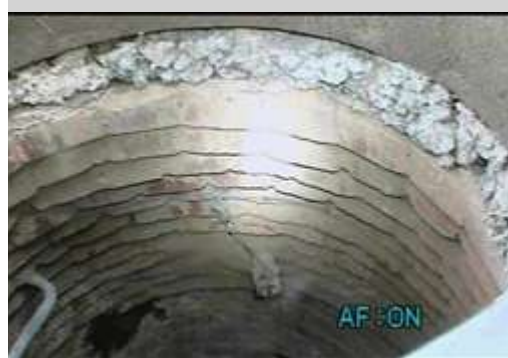
Defect 1

Condition: ☐ Sound ☐ Cracked ☐ Root Intrusion ☐ Loose Brick ☒ **Deteriorated**

chimney deteriorated

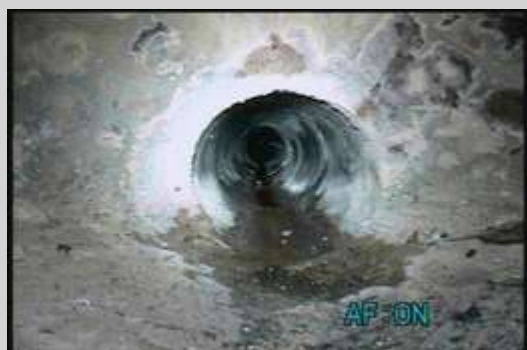
12 O'Clock Outflow

8 in. Circular Gravity Sewer  
Pipe Out @ 12 O'Clock

Pipe Material: **Clay** ☐ Pipe Lined

Invert Depth: **6.40** (ft.) Flow Characteristics: **None**

Infiltration: **None** Pipe Seal Cond: **Unknown**
